BUILDING ENCLOSURE INVESTIGATION AND ANALYSIS
CENTENNIAL CONDOMINIUMS
ASPEN, CO

2010.07.22

Stephen W. Bossart
Project Manager
Capital Asset Department
City of Aspen

Peter Baker, P.Eng.
Senior Associate
Building Science Corporation

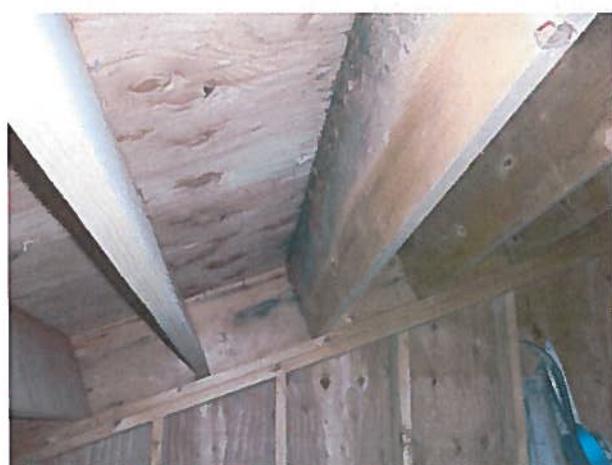
There was no observed evidence of water intrusion in the attic. However, there were multiple locations of condensation staining on the framing close to the roof or exterior wall sheathing (See Figure 7). Evidence of condensation was most significant near the dryer vent attachment to the exterior wall (See Figure 8).

Figure 7: Attic condensation stains

The resulting moisture load is greater than can be managed by the ventilation scheme. As a result, condensation accumulates at various places on sheathing and framing at the exterior surfaces.

1. Add additional lower vent openings, including soffit vents at the eave overhang extensions.
2. Replace pull down ladder access hatched with gasketed and sealed hatches (a secondary hatch cover should also be considered given the high potential for infiltration through the attic hatch).
3. Air seal gypsum ceiling at all partition walls, electrical and mechanical penetrations, and exterior framed wall.

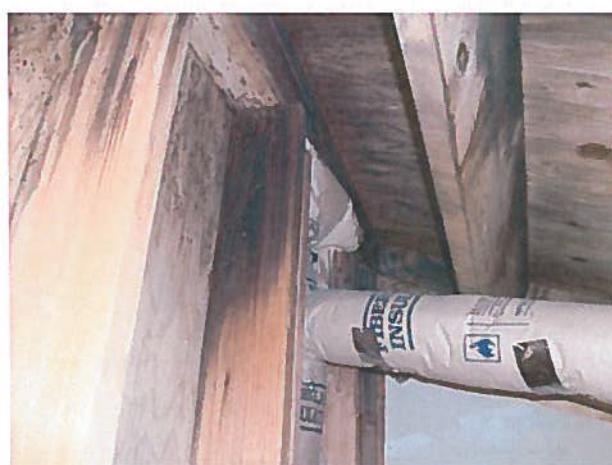
Figure 8: Attic condensation stains at dryer vent

1. Ensure all dryer exhaust ducts are properly ducted to the exterior. Seal around all connections to prevent leakage of dryer exhaust into the attic space.
2. Duct all bathroom exhaust fans properly to the exterior.

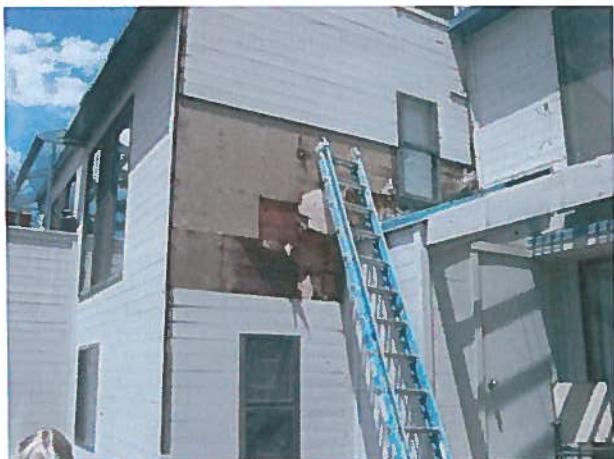
Figure 11: Investigation of SE wall

Many of the roof/wall intersections, especially on the southwest side of the buildings, showed evidence of peeled paint. Based on homeowner reports of water intrusion at exterior storage closets, a roof/wall intersection at one of the storage closets was selected for further investigation (Figure 11).

Upon removal of the siding, it was observed that the exterior gypsum board was water damaged along the sloped intersection of the wall and the roof. The exterior gypsum board was crumbling at the roof/wall connection. For several inches above the connection, the outer paper surface of the gypsum board was peeling away but the gypsum core remained intact. The plywood wall sheathing behind the gypsum board appeared undamaged. The water damage was more extensive towards the outer edge of the roof.

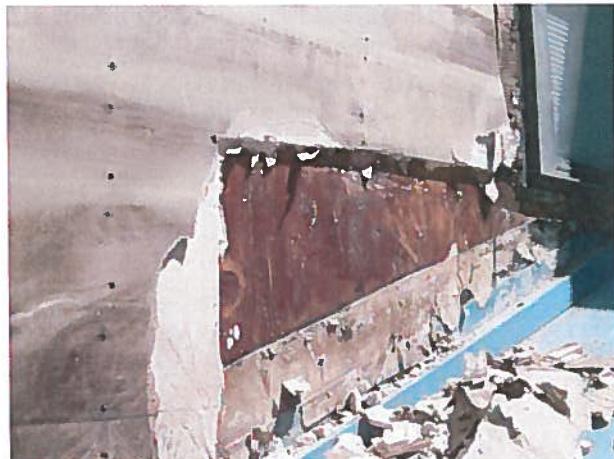
Figure 12: Investigation at roof/wall connection

It was observed that the roof underlayment was turned up several inches and sealed to the exterior plywood wall sheathing. The connection between the metal deck and the wall sheathing was covered with a continuous bent sheet metal flashing. The sheet metal flashing was noted to be flashed back to the plywood wall sheathing. This places the flashing behind the exterior gypsum board (See Figure 12).

Because the flashing was installed behind the exterior gypsum board layer it created a hole at the roof edge termination in the field of the wall. This hole funneled water that was draining down along the flashing in between the gypsum and plywood sheathing. The location was particularly susceptible to water infiltration due to ice dams. The ice dams created a situation that allowed the water to back up above the height of the lower flashing leg and subsequently drain into the wall assembly. This analysis was corroborated with the reported history of the building that identified problems occurring more often during times of ice damming.

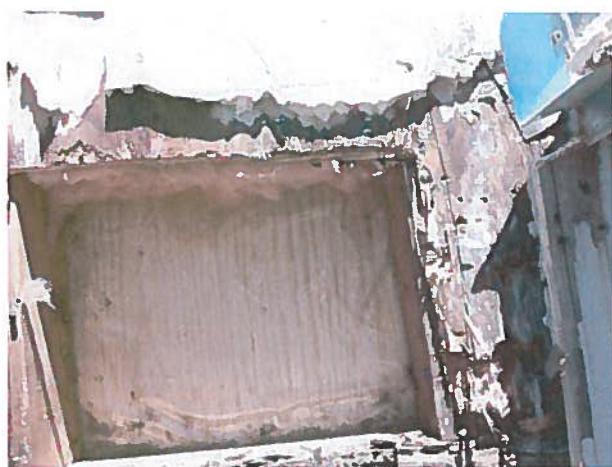
Figure 13: Investigation at wall/wall connection

The investigation was continued at this location by removing the siding down along the wall-to-wall connection at the exterior of the storage closet. Here, the exterior gypsum board was water damaged and crumbled. This extended out approximately 12" from the wall-to-wall intersection. Since the plywood sheathing showed water staining, a cut was made in the plywood to investigate the wall structure. No damage to the studs was evident at this location (See Figure 13).

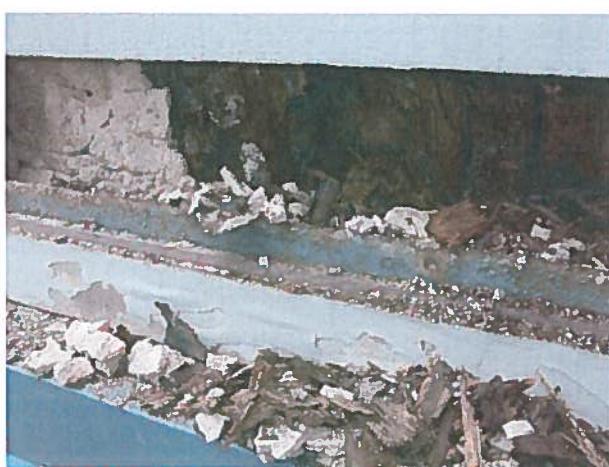
Figure 14: Investigation at base of wall

The siding was then removed at the base of this exterior wall. Here extensive damage was observed with both the exterior gypsum board and the plywood crumbling and evidence of rot along the outside edge the wall studs (See Figure 14). Note that at this location, the concrete foundation wall and sill plate is proud of the siding; metal flashing covers the extension.

The leakage at the roof to wall connections is resulting in damage of the first floor structure where the wood frame structure is connected to the concrete foundation. The buildings are designed with the framing set back from the exterior edge of the foundation wall (Figure 36). This created a ledge for the water to accumulate at the base of the wall assembly. Removal of the siding material at the base of the southeast facing wall during the field investigation revealed that the framing had deteriorated (Figure 37).

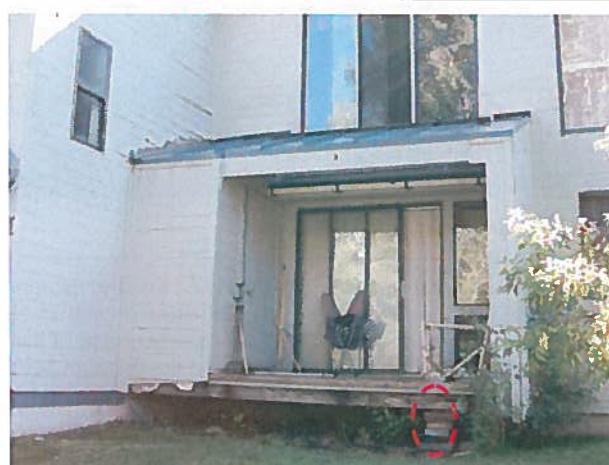
It should be noted that the first floor decks on the southwest side of the buildings were originally constructed as cantilevered structures. There was water damage reported in the past at the decks –all the original stairs were removed because of damage – and damage can be seen to the some of the structure underneath. (See Figure 15) In some cases, homeowners have added support underneath suggesting that the original decks may be sagging. (See Figure 16)

Figure 16: SW porch with added "support"

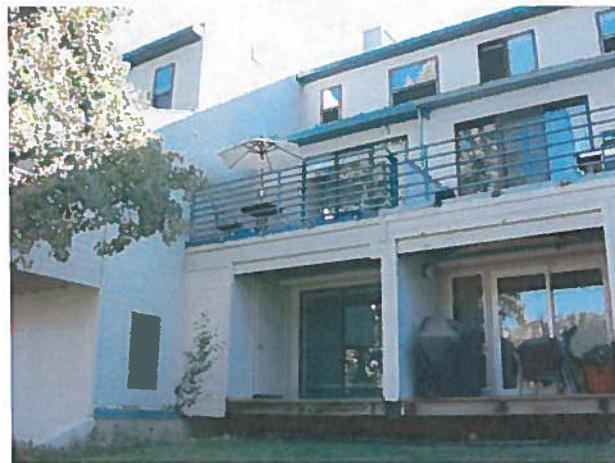
Figure 17: Example of deck over storage closet

Some homeowners have added decks at the second floor on the southwest side. By doing so, they replaced the original roof structure at the exterior storage closets below. Figure 17 shows an example of this.

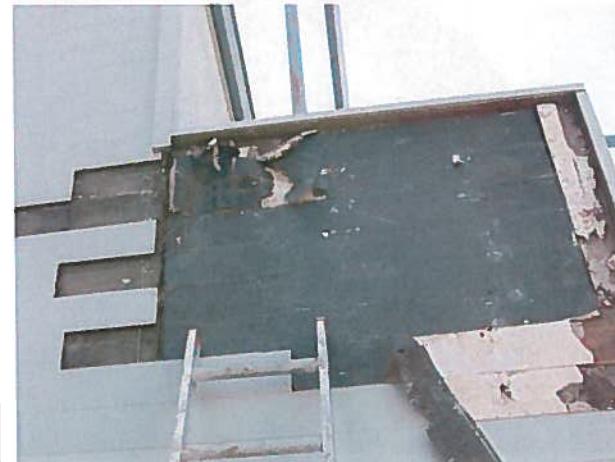
Figure 19: Wing wall built over existing structure

Without water proofing or flashing installed at the balcony wing walls, water is able to penetrate directly into the structure below. The removal of the wood siding at the wing wall to structural wall interface revealed a concentration of deteriorated material at the interface.

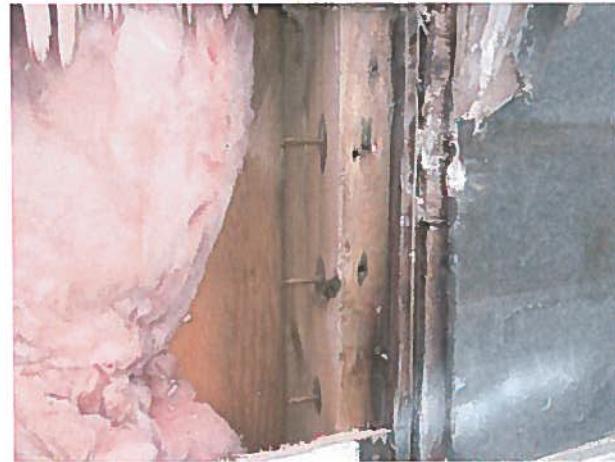
It was reported that there has been water intrusion in the storage closets with modified construction as well as in the original construction. Therefore a disassembly investigation was performed at the wall along one such deck. (See Figure 18) In this case, the original side wall was extended up to form a wing wall for the 2nd floor deck. Siding was removed from the wing wall to check for water damage which can be seen on the exterior gypsum board at several places (Figure 19). A cut was made through the plywood in the building wall at the connection point to see if the water damage extended into the wall. There was dampness felt in the stud space, but no damage to the stud could be seen (Figure 20).

Figure 20: Wing wall attachment to building

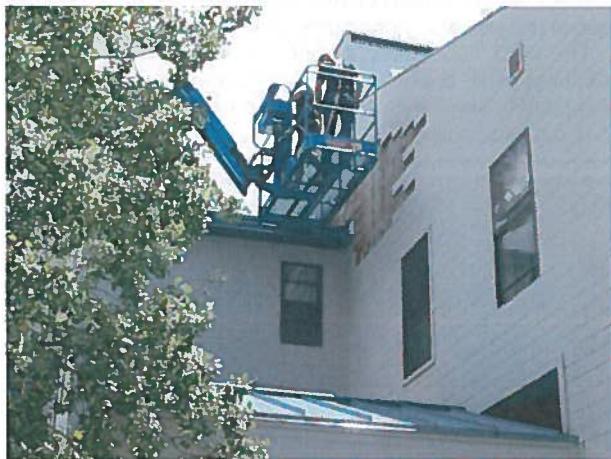
Figure 21: Investigation at NE wall at roof/wall

The next field disassembly was located at a roof/wall intersection along the northeast side of the building (Figure 21). The siding was removed so the condition of the wall could be examined (Figure 22). There was some water staining on the face of the exterior gypsum board causing peeling of its outer layer but the core was not damaged. The gypsum board was broken off to look at the plywood behind, which was not damaged. The roof/wall flashing detail was similar to that described earlier.

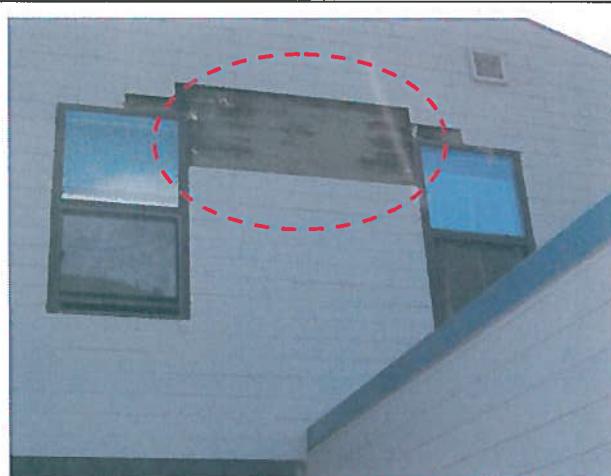
Figure 23: Investigation at NE wall (field)

Additional investigation openings were made at two locations – in the wall field on a northeast wall and on a southeast wall. At the location on the northeast wall, when the siding was removed, some water stains could be seen on the face of the exterior gypsum board at siding nail penetration and around the windows, but there was no deterioration (See Figure 23). It should be noted that there is no overhang over this wall. On the other hand, along the southwest wall, where there is an overhang, no water staining of the exterior gypsum board was observed (See Figure 24).

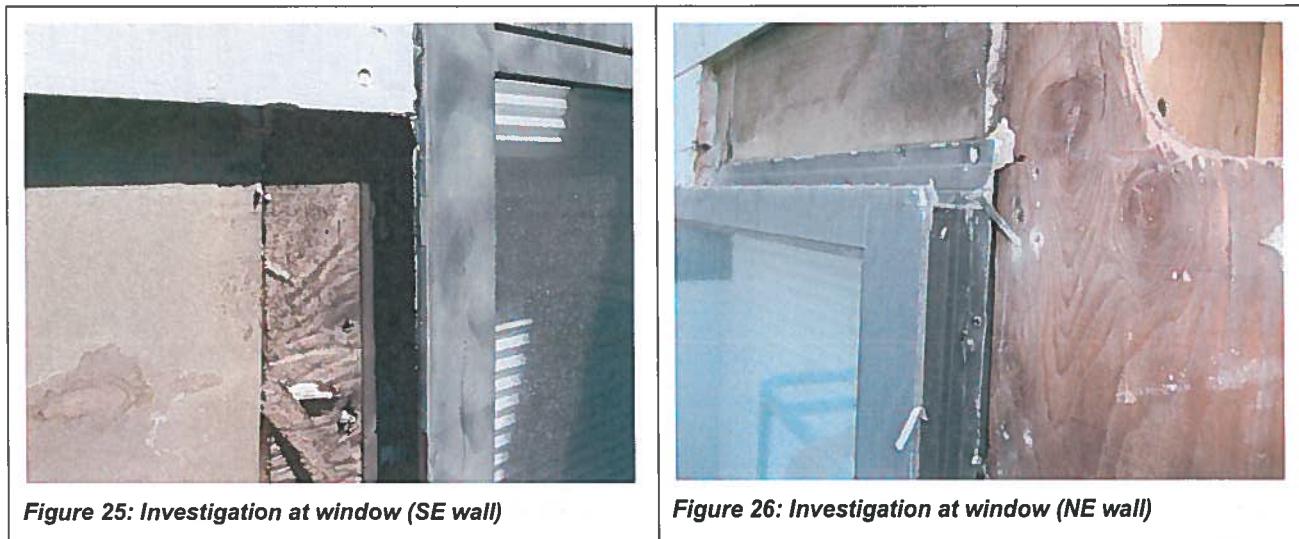
The windows from the original construction are still in place. They are double glazed windows and some are reported to be experiencing condensation within the glazing. The siding was removed at a window on the southwest side of the building (on a southeast facing wall) and at a window on the northeast side of the building to check for water damage around the windows (See Figure 25 and Figure 26). In both cases, the windows are on walls for which there is no overhang. There was no flashing observed at the windows. There was some water staining on the exterior gypsum board around both of the windows and on the plywood behind. The plywood was cut at the window on the northeast side to check for damage inside the wall, but none was observed.

Figure 25: Investigation at window (SE wall)

Figure 26: Investigation at window (NE wall)

Since the windows are original to the building and no flashing was applied when they were installed, there is potential for water intrusion at each windows. Based on the observed water staining of the exterior gypsum board around the windows, some water is getting behind the cladding at the windows; however the observed damage was not extensive around the openings.

We do recommend Option3 as a means to reduce the risk of water infiltration concerns in the building. This option does not improve the thermal performance and it does not address the aesthetic issue of the condensation within the sealed insulating glass units.

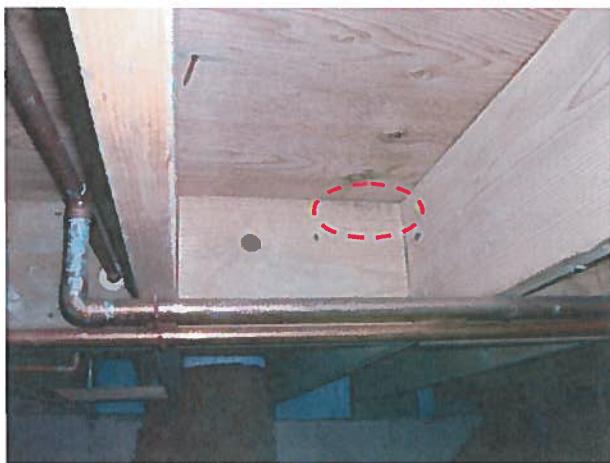
In general, the subfloor and framing was clean and free of water staining. However, there was occasional evidence of condensation. This can be seen on the blocking above plumbing pipes in Figure 29. There was also evidence of condensation along the rim joist (See Figure 30). No structural water damage was observed on the floor framing or on any portions of the rim board that were examined.

Figure 29: Piping in Basement

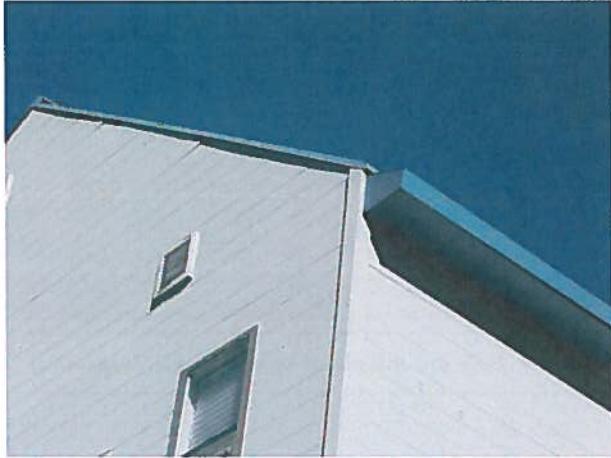
End walls that do not have an overhang were noted to have increased wear on the system due to the exposure. Water infiltration behind the cladding has lead to staining and minor deterioration of the paper facing on the exterior gypsum sheathing. It was noted however that in these locations, the core of the gypsum was still solid and undamaged as well as the plywood sheathing behind it.

Figure 35: Rake edge at end wall and eave overhang extension
