BUILDING ENCLOSURE INVESTIGATION AND ANALYSIS
CENTENNIAL CONDOMINIUMS
ASPEN, CO

2010.07.22

Stephen W. Bossart
Project Manager
Capital Asset Department
City of Aspen

Peter Baker, P.Eng.
Senior Associate
Building Science Corporation

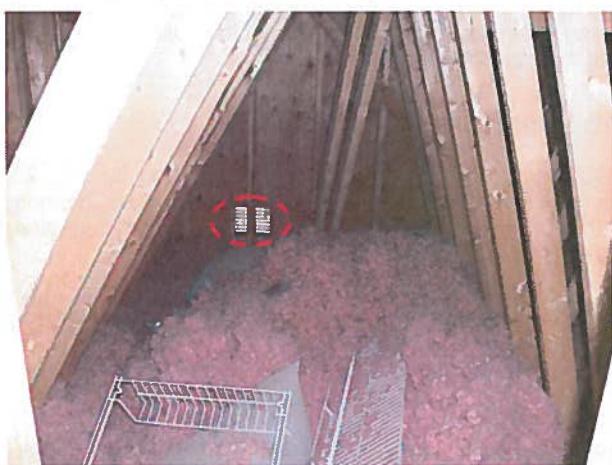
Figure 6: Attic Vent from Interior

The surveyed attic was accessed via a pull-down stair. The access hatch was not gasketed; it had been taped shut by the homeowner for air-sealing. In the attic, only one vent was observed (Figure 6). There may have been another similarly sized vent along the side wall on the southwest end of the attic.

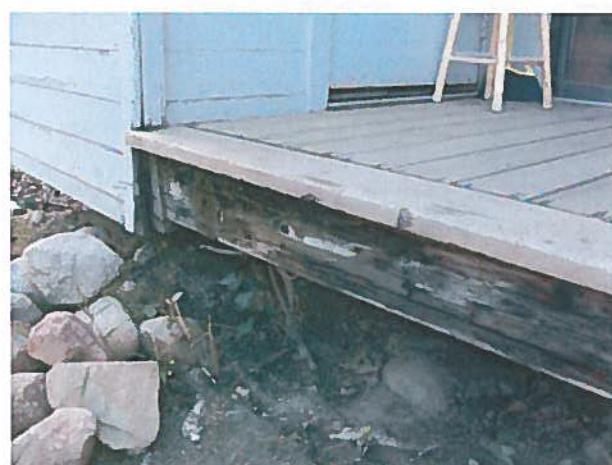
Figure 15: SW porch deck

It should be noted that the first floor decks on the southwest side of the buildings were originally constructed as cantilevered structures. There was water damage reported in the past at the decks –all the original stairs were removed because of damage – and damage can be seen to the some of the structure underneath. (See Figure 15) In some cases, homeowners have added support underneath suggesting that the original decks may be sagging. (See Figure 16)

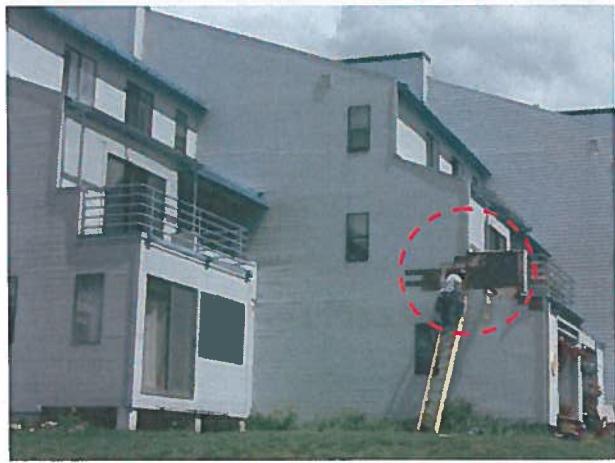
Figure 18: SW porch with added

It was reported that there has been water intrusion in the storage closets with modified construction as well as in the original construction. Therefore a disassembly investigation was performed at the wall along one such deck. (See Figure 18) In this case, the original side wall was extended up to form a wing wall for the 2nd floor deck. Siding was removed from the wing wall to check for water damage which can be seen on the exterior gypsum board at several places (Figure 19). A cut was made through the plywood in the building wall at the connection point to see if the water damage extended into the wall. There was dampness felt in the stud space, but no damage to the stud could be seen (Figure 20).

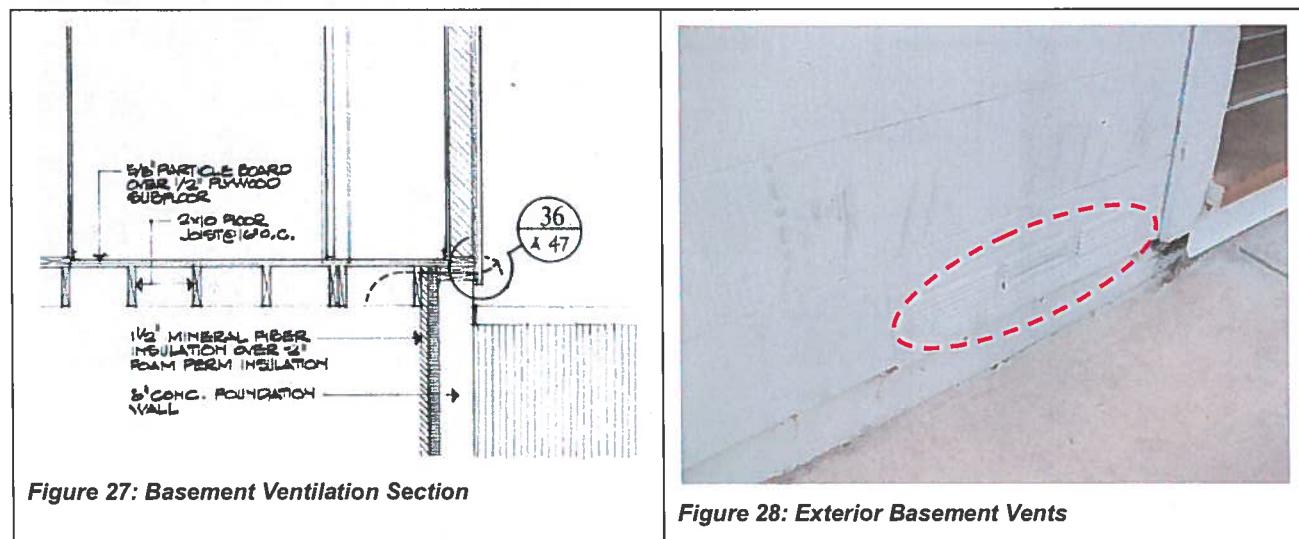
Figure 27: Basement Ventilation Section

The crawlspace is a ventilated, insulated space (See Figure 27). Crawlspace vents were observed along the northeast façade and are also called out in the drawings to be located on the southwest under the first floor porches. The framing and the first floor subfloor are exposed. There is no insulation between the first floor and the crawlspace (See Figure FS-3). Each unit contains its own water heater and heating is provided by electric baseboard. So there is no equipment in the crawlspaces other than plumbing and wiring. During the survey, the crawlspace was not damp nor did it smell musty.

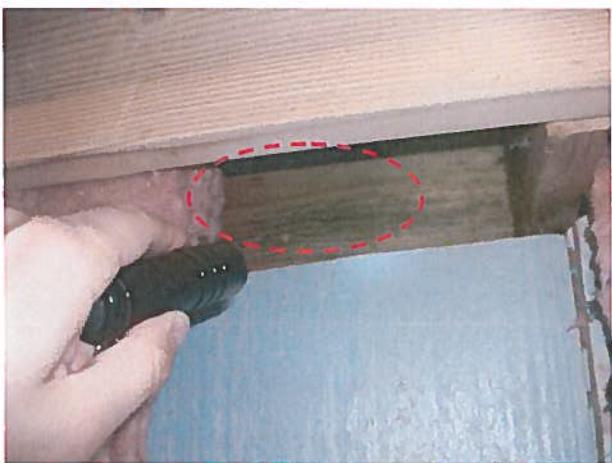
Figure 30: Rim board

In general, the subfloor and framing was clean and free of water staining. However, there was occasional evidence of condensation. This can be seen on the blocking above plumbing pipes in Figure 29. There was also evidence of condensation along the rim joist (See Figure 30). No structural water damage was observed on the floor framing or on any portions of the rim board that were examined.

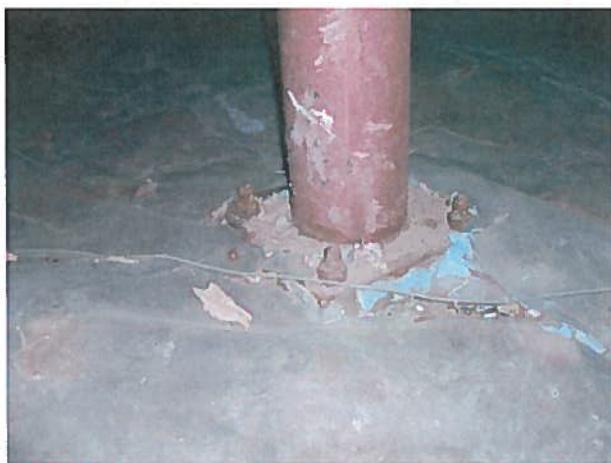
Figure 33: Poly ground cover at lally column

The walls of the crawlspace are insulated with a layer of XPS against the concrete foundation wall which is covered with a blanket of fiberglass insulation. The crawlspace floor has a continuous ground cover of polyethylene. The ground cover is sealed to the footing at the interior columns (Figure 33) and is sealed to the XPS at the walls (Figure 34).
